ARMY RESEARCH LABORATORY

Mechanical Tests and Failure Analysis on Selected Components of the Class 60 Armored Vehicle Launched Bridge (AVLB) During the Class 70 Modification Program

ARL-TR-1269

December 1996

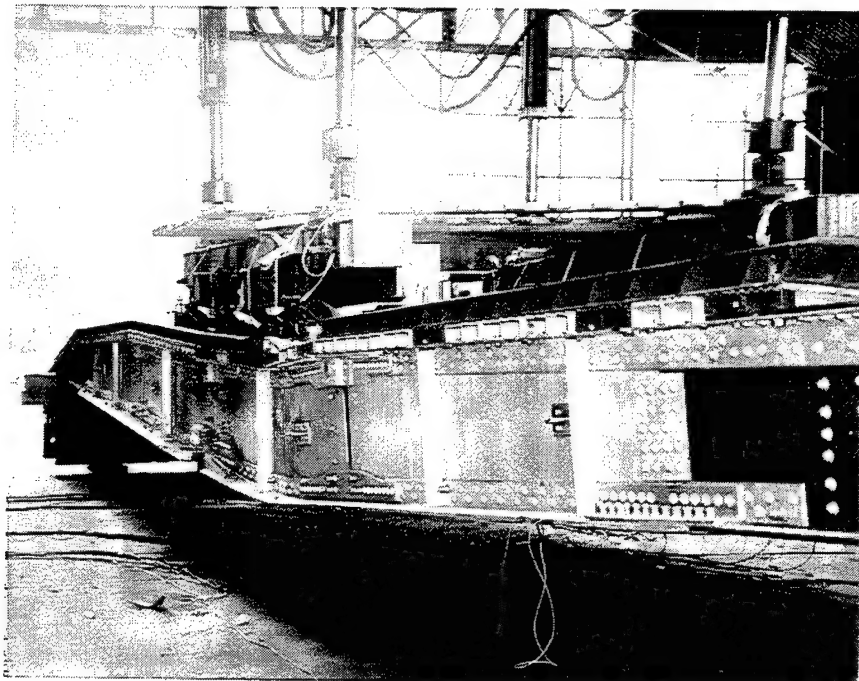
Figure 121. A side view of the collapsed No. 2 Class 70 modified AVLB after the bridge failure test. It buckled in the top chords and girder plates in the center panel assembly of the female bridge section.

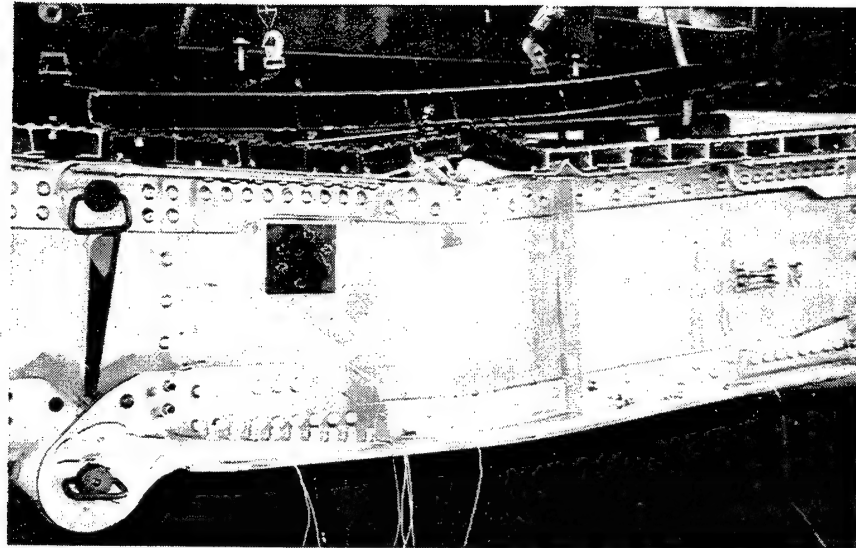
Figure 122. Close-up view of the buckled area in the No. 2 bridge in Figure 121. Note the extensive damages to the top chord, girder plate, extruded aluminum deck panels, and steel curb. The modified bottom chord angles did not crack, but bent at the buckled area. The buckling occurred closer to the center hinges of the female bridge section than in the other female section in Figure 124.

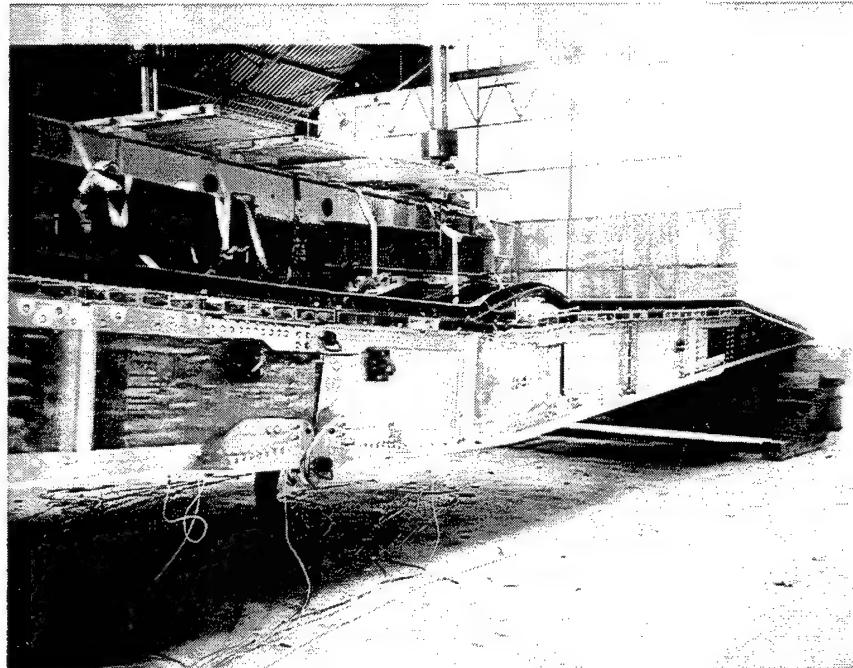
Figure 123. A view of the other side of the collapsed No. 2 bridge in Figure 121. It buckled in the top chords and girder plates in the center panel assembly of the other female bridge section.

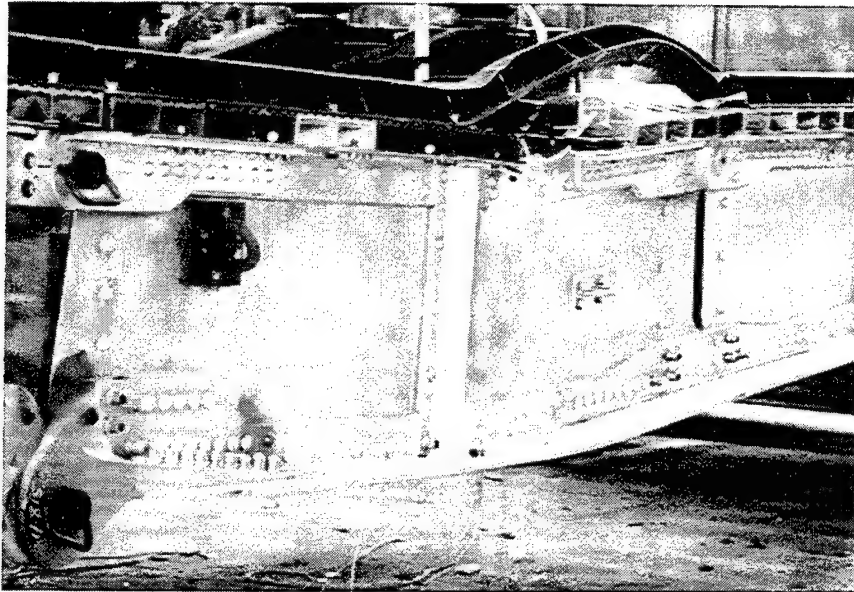
Figure 124. Close-up view of the buckled area in the No. 2 bridge in Figure 123. Note the extensive damages to the top chord, girder plate, extruded aluminum deck panels, and steel curb. The modified bottom chord angles did not crack, but bent at the buckled area.

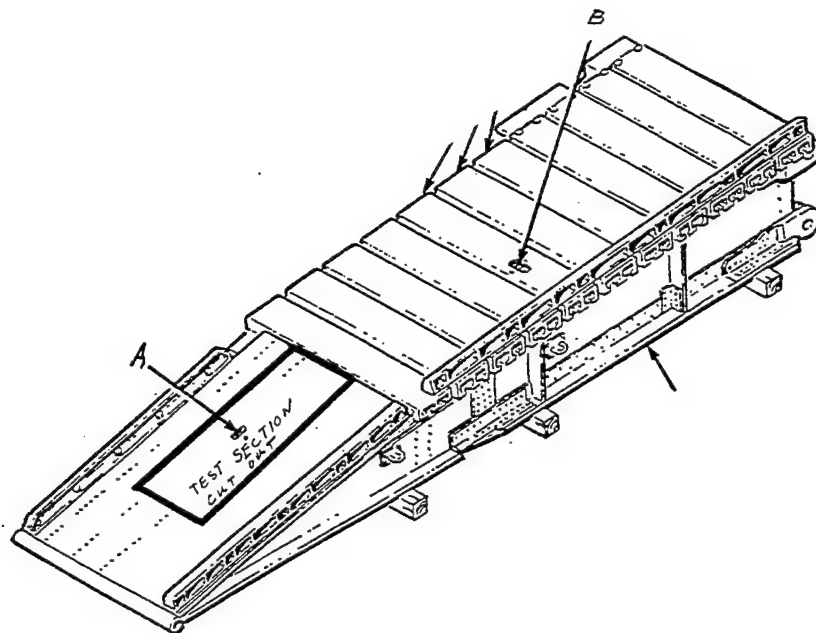
The next series of the pull tests performed was on the lifting device in the ramp deck section of the AVLB end panel assembly. In this case, a large section (30 in wide and 60 in long), containing the oblong hole with the lifting steel bar, was cut from a male end panel assembly to serve as a test specimen (see Figure 125 for the location of the section and Figures 69–71). The section contained three 6-in \times 2 1/2-in aluminum channels in the longitudinal direction with both ends connected to the aluminum plates with the sections of aluminum and steel angles and aluminum buttonhead rivets in order to retain the integrity of the deck section for the pull tests of the lifting bar samples. The 1/2-in-thick aluminum tread floor plate was still fastened by aluminum countersunk head rivets to the flanges of the channels and angles on the ends. The oblong hole in the floor plate was between two channels.

- Another original lifting steel bar was removed from the same AVLB end panel from which the large test section was cut. It was at location B in Figure 125. The bar was installed in the test section

Figure 125. Sketch of the AVL B end panel assembly showing the location of the large test section cut from the lower ramp end with respect to the location of the lifting bar at point A.
